BRONSON POND DAM

NDI ID NO. PA-00143
DER ID NO. 64-42

PHASE I INSPECTION REPORT NATIONAL DAM INSPECTION PROGRAM

DEPARTMENT OF THE ARMY
Baltimore District, Corps of Engineers
Baltimore, Maryland 21203

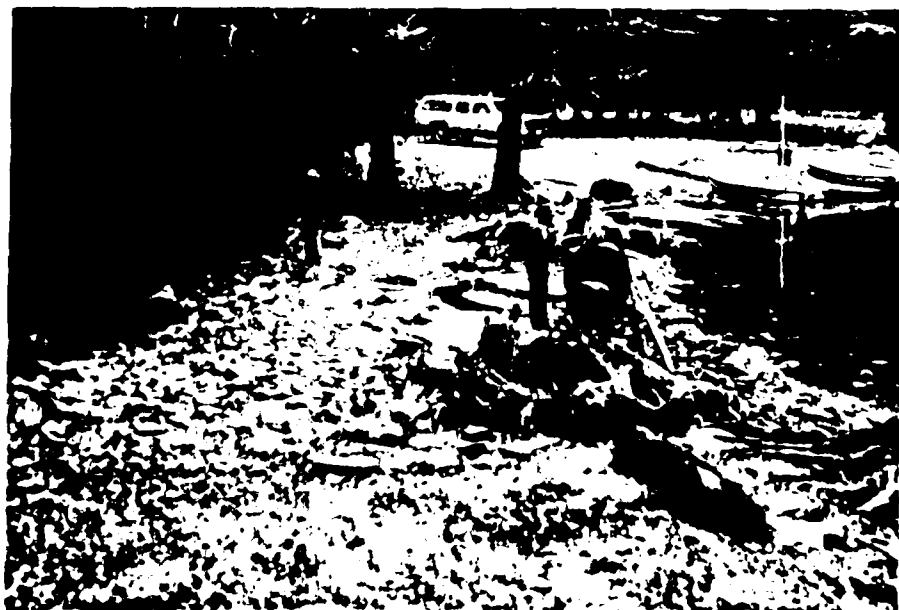
Two large trees, two and one-half feet in diameter, are growing on the right abutment adjacent to the crest. Additional trees are growing on the abutments adjacent to the downstream face.

2. Embankment crest and right abutment.
